WSP/OSPI Inspection Interpretations (March 2025)

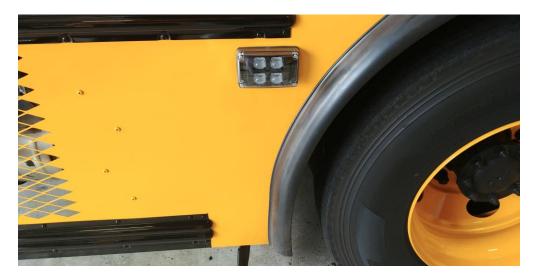
It has been brought to our attention that some buses are arriving with lighting on both sides of the bus (see below) that does not meet our specifications. Some buses were inadvertently issued initial inspection forms with these lights on them before we became aware of them. These lights will need to be removed.
